# Manhole Inspection Summary

Manhole # S69M\_\_011MH

Insp Date: 1/31/08 2:13 PM

**Location** Address: **1111 Steelton Ave.**

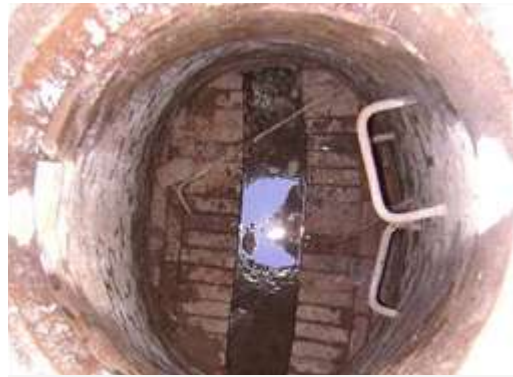
Top View

Condition: ☐ Sound ☐ Cracked ☐ Root Intrusion ☒ **Loose Brick** ☐ Deteriorated

Infiltration: ☐ None ☒ **Joint** ☐ Cracks ☐ Mortar ☐ Roots ☐ Wall

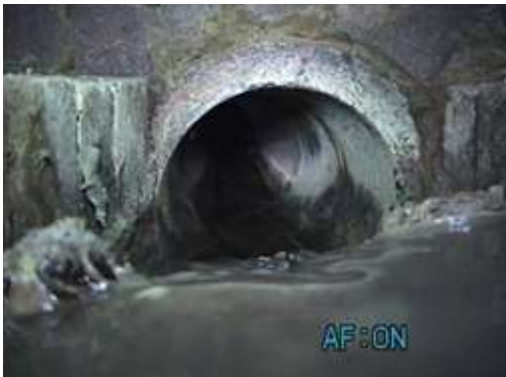
Defect 1

Comments **HEAVY DEBRIS IN CHANNEL.**

Condition: ☐ Sound ☐ Cracked ☐ Root Intrusion ☐ Deteriorated ☐ Leaks ☒ **Debris**

outgoing 12 o'clock connection, debris blocking channel

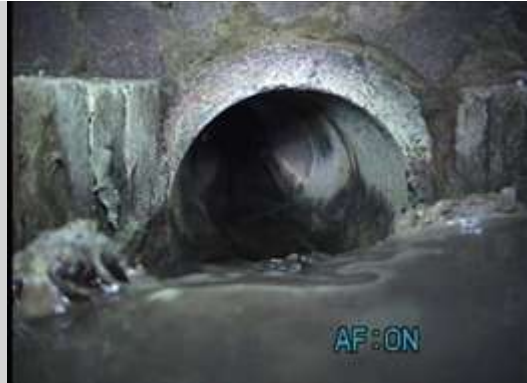
12 O'Clock Outflow

8 in. Circular Gravity Sewer  
Pipe Out @ 12 O'Clock

Pipe Height: **8.4** (in.) Rod and Bar (Angled)  
Pipe Material: **Clay** ☐ Pipe Lined  
Invert Depth: **8.21** (ft.) Flow Characteristics: **Slow**  
Deposits: ☐ None ☐ Mud ☒ **Sludgy** ☒ **Debris** ☐ Grease  
Silt Depth: **4** (in.) Deposits Extent: **Heavy**  
Infiltration: **None** Pipe Seal Cond: **Sound**

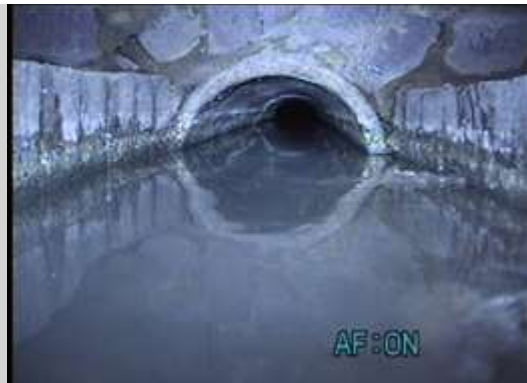
6 O'Clock Inflow

8 in. Circular Gravity Sewer  
Pipe In @ 6 O'Clock

Pipe Height: **8.4** (in.) Rod and Bar (Angled)  
Pipe Material: **Clay** ☐ Pipe Lined  
Invert Depth: **8.17** (ft.) Flow Characteristics: **Slow**  
Deposits: ☐ None ☐ Mud ☒ **Sludgy** ☒ **Debris** ☐ Grease  
Silt Depth: **4** (in.) Deposits Extent: **Heavy**  
Infiltration: **None** Pipe Seal Cond: **Sound**
